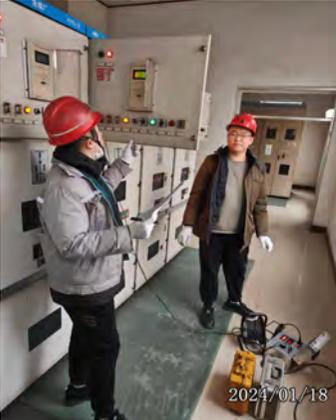
序号	报告编号	发布日期	结论	影像资料
1	GX-B1495/20-2-24021~24033	2024. 2. 1	本次共检高压开关柜13台，13台所检项目合格。

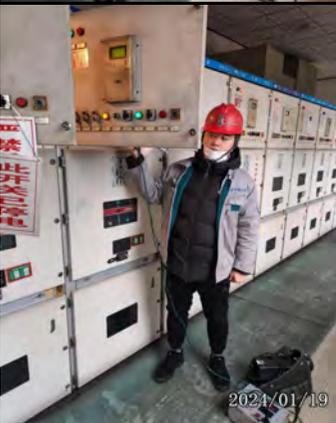
2	GX-B1495/20-2-24034~24042	2024. 2. 1	本次共检高压开关柜9台，9台所检项目合格。

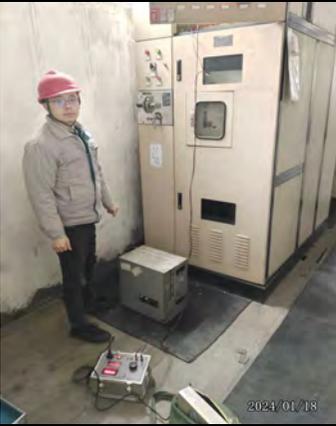
3	GX-B1495/20-2-24079~24080	2024. 2. 1	本次共检高压开关设备2台，2台所检项目合格。

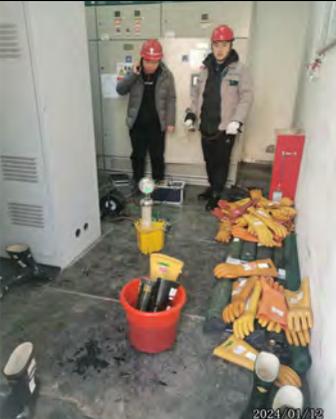
<p>2024/01/19</p>
8	GX-B1328/20-2-24005	2024. 2. 1	本次共检绝缘手套46只，46只所检项目合格。

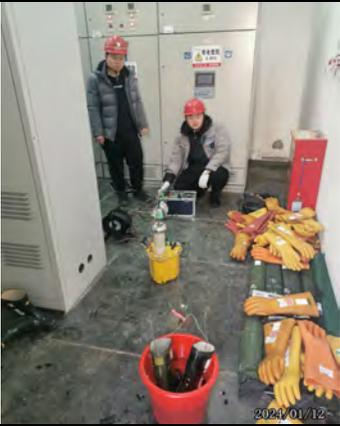
9	GX-B1328/20-2-24006	2024. 2. 1	本次共检绝缘鞋42只，42只所检项目合格。

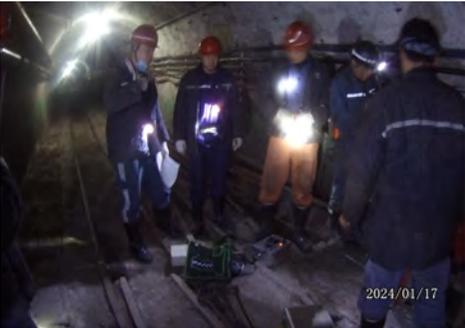
23	GX-B1495/20-2-24006~24008	2024/2/1	本次共检高压防爆开关3台，3台所检项目合格。

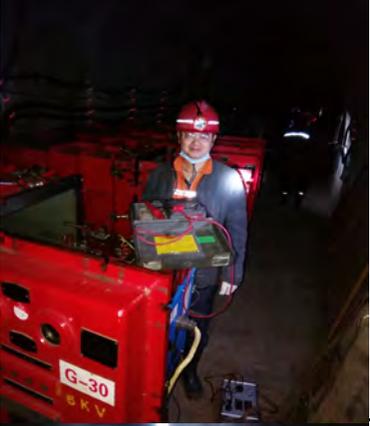
24	GX-B1495/20-2-24009~24012	2024/2/1	本次共检高压防爆开关4台，4台所检项目合格。

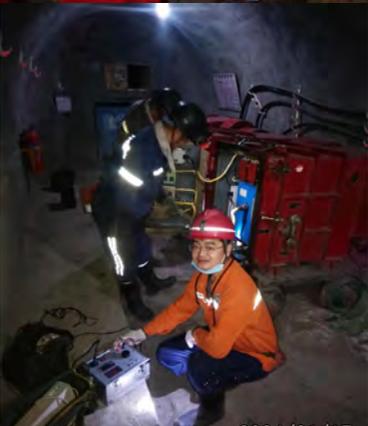
25	GX-B1495/20-2-24013~24020	2024/2/1	本次共检高压防爆开关8台，8台所检项目合格。

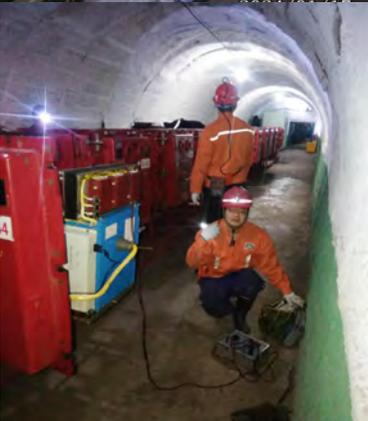
26	GX-B1495/20-2-24043~24050	2024/2/1	本次共检高压防爆开关8台，8台所检项目合格。

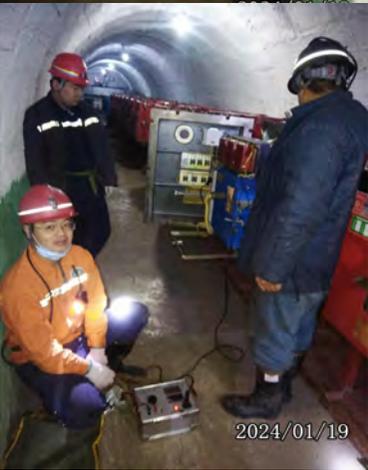
27	GX-B1495/20-2-24051~24056	2024/2/1	本次共检高压防爆开关6台，6台所检项目合格。

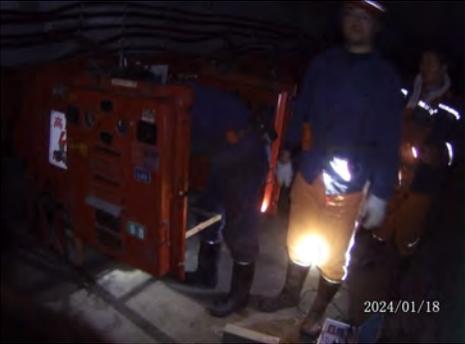
28	GX-B1495/20-2-24057~24060	2024/2/1	本次共检高压防爆开关4台，4台所检项目合格。

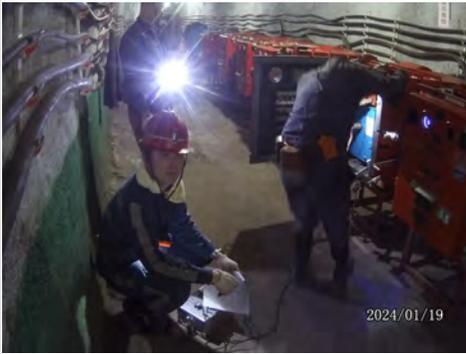
29	GX-B1495/20-2-24061~24064	2024/2/1	本次共检高压防爆开关4台，4台所检项目合格。

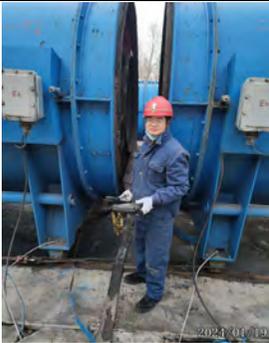
A worker in a blue uniform and red helmet is inspecting a large, dark-colored industrial component, possibly a turbine or engine part. The worker is standing in a narrow space between the component and another structure. A date stamp '2024.01.18' is visible in the bottom right corner of the image.
34	GX-B1310/21-2-24017	2024/2/2	未发现超过 $\Phi 2\text{mm}$ 当量直径的缺陷。

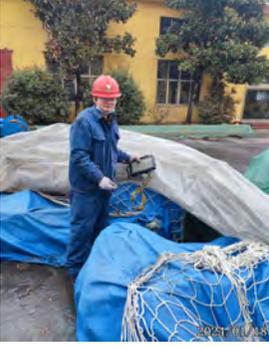
35	GX-B1310/21-2-24018	2024/2/2	未发现超过 $\Phi 2\text{mm}$ 当量直径的缺陷。
