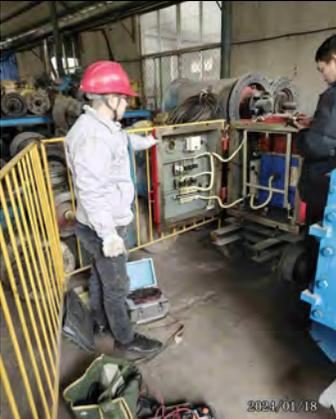
4	GX-B1495/20-2-24081	2024. 2. 1	所检项目合格。

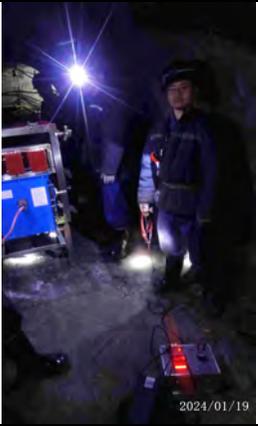
5	GX-B1495/20-2-24082	2024. 2. 1	所检项目合格。

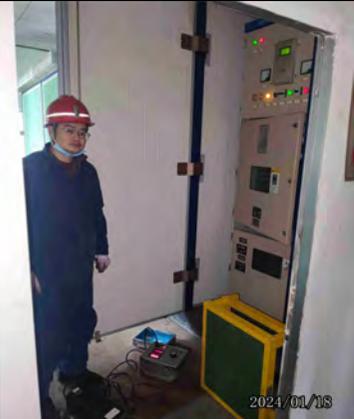
6	GX-B1495/20-2-24004	2024. 2. 1	所检项目合格。

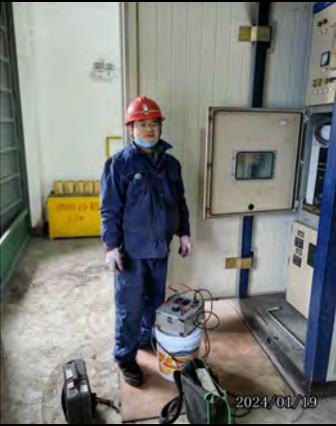
7	GX-B1495/20-2-24005	2024. 2. 1	所检项目合格。

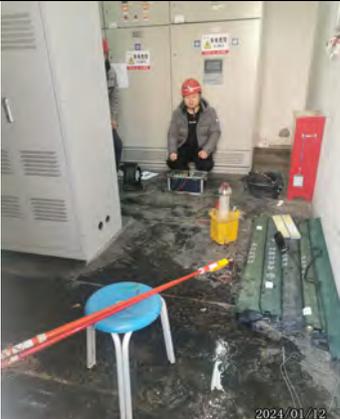
A photograph showing two workers in a control room. One worker is kneeling on the floor, and the other is standing. They are surrounded by various safety equipment, including a red bucket, a yellow bucket, and several pairs of yellow and orange safety gloves. The date '2024/01/12' is visible in the bottom right corner of the photo.
10	GX-B1328/20-2-24007	2024. 2. 1	本次共检验电器2支，2支所检项目合格。

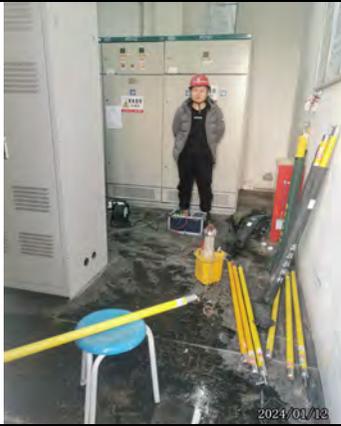
11	GX-B1328/20-2-24008	2024. 2. 1	本次共检绝缘杆5组，5组所检项目合格。

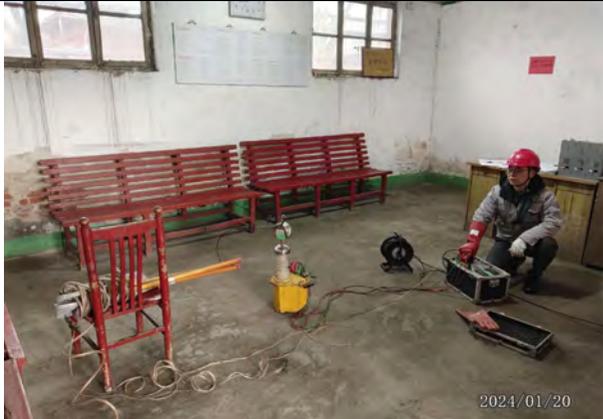
12	GX-B1328/20-2-24009	2024. 2. 2	所检项目合格

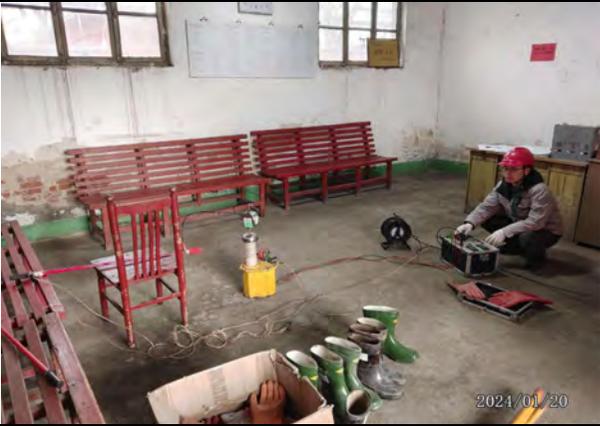
13	GX-B1328/20-2-24010	2024. 2. 2	所检项目合格

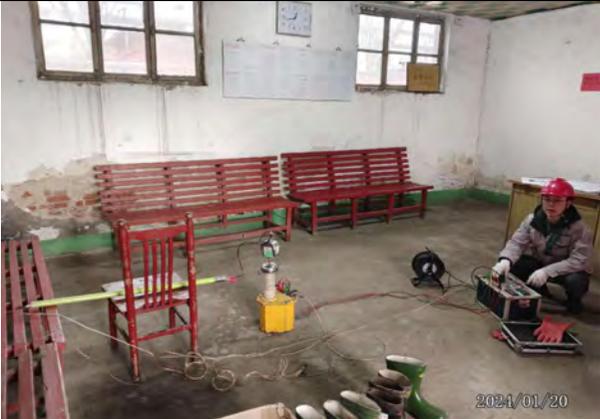
14	GX-B1328/20-2-24011	2024. 2. 2	所检项目合格

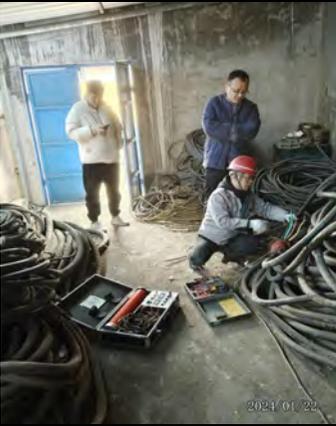
15	GX-B1321/20-2-24040~24043	2024. 2. 2	所检项目合格

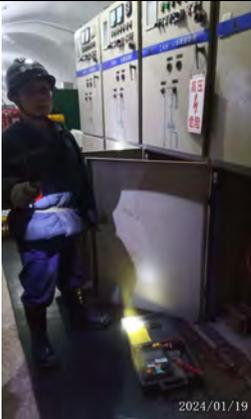
<p>2024/01/22</p>
16	GX-B1321/20-2-24030~24039	2024. 2. 2	所检项目合格

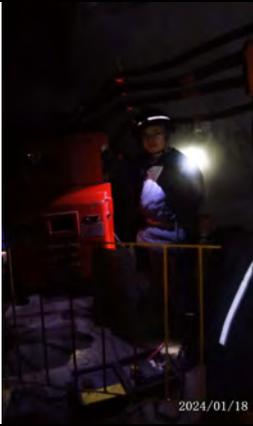
17	GX-B1321/20-2-24023~24029	2024. 2. 2	所检项目合格

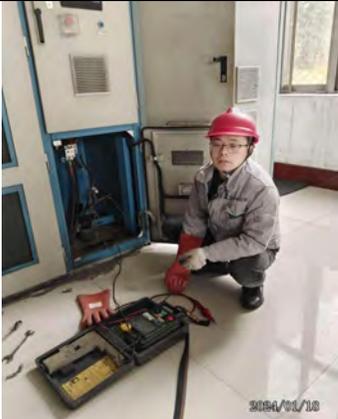
18	GX-B1321/20-2-24016~24022	2024. 2. 2	所检项目合格

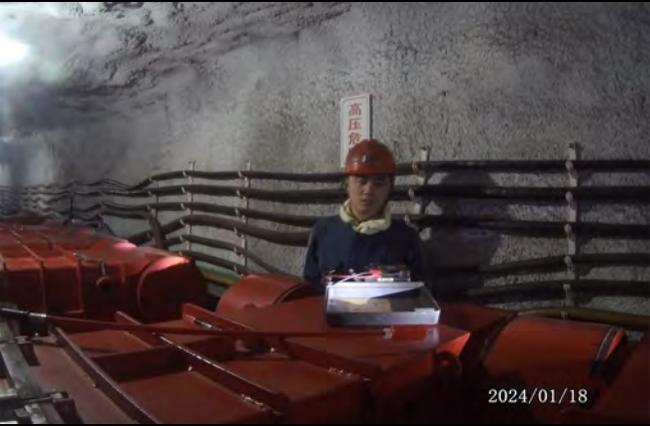
19	GX-B1321/20-2-24044	2024. 2. 2	所检项目合格

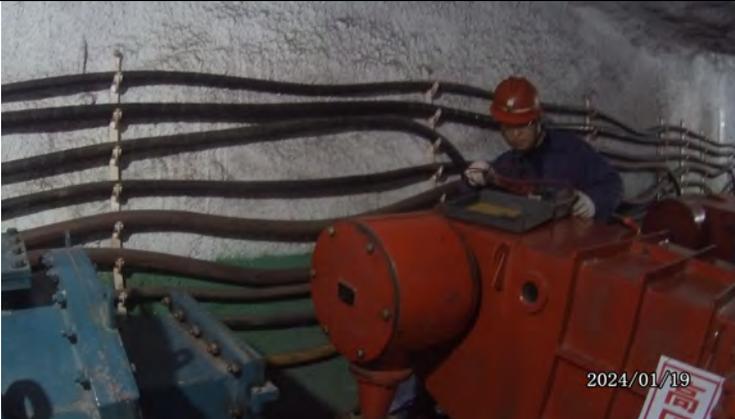
20	GX-B1321/20-2-24045~24046	2024. 2. 2	所检项目合格

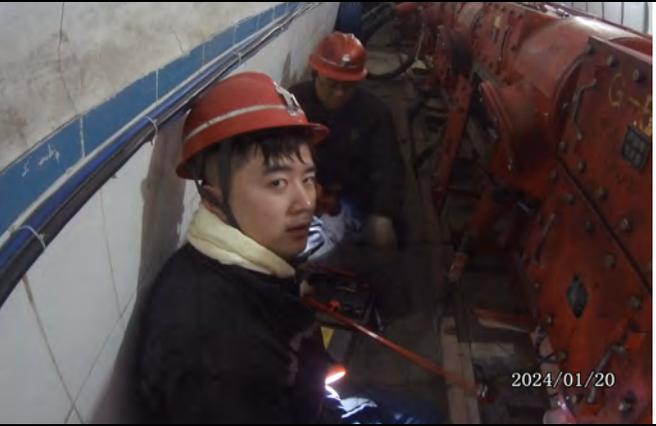
21	GX-B1321/20-2-24047~24053	2024. 2. 2	所检项目合格

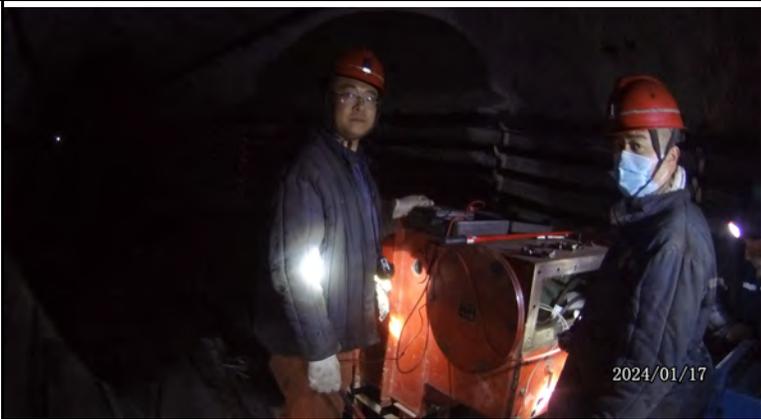
22	GX-B1321/20-2-24010~24015	2024. 2. 2	所检项目合格

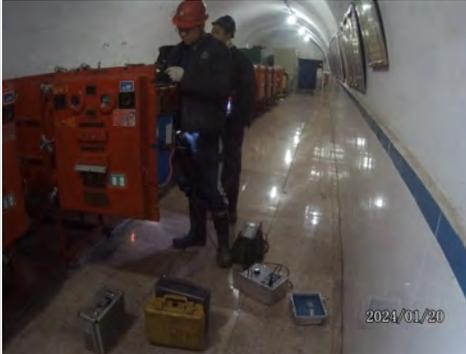
A photograph showing two workers in a tunnel environment. One worker in the foreground is wearing a blue jacket and a red hard hat, looking down at a device. Another worker is visible in the background, also wearing a red hard hat. The scene is dimly lit with a bright light source. A timestamp '2024/01/19' is visible in the bottom right corner of the image.
30	GX-B1495/20-2-24065~24078	2024/2/1	本次共检高压防爆开关14台，14台所检项目合格。

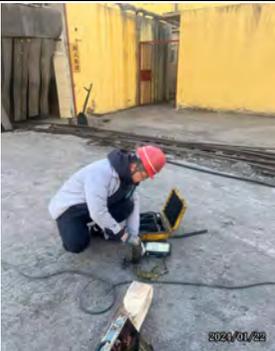
<p>2024/01/20</p>
32	GX-B1310/21-2-24015	2024/2/2	符合标准要求

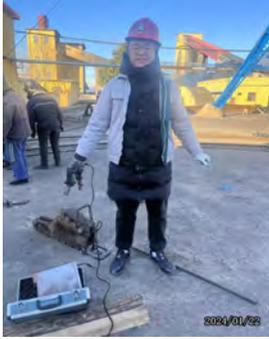
36	GX-B1427/21-2-24015	2024/2/2	符合标准要求

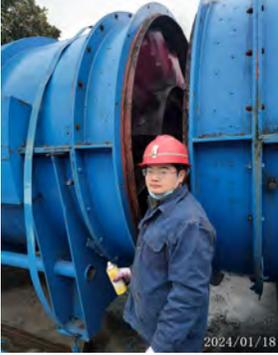
37	GX-B1428/21-2-24016	2024/2/2	无缺陷迹痕显示

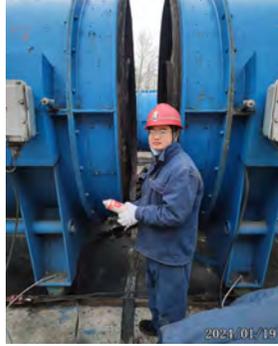
38	GX-B1428/21-2-24017	2024/2/2	无缺陷迹痕显示

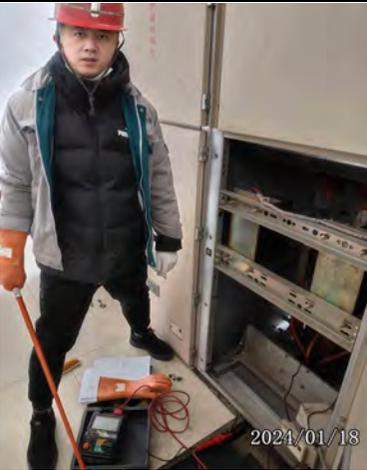
39	GX-B1321/20-2-24065~24069	2024/2/4	所检项目合格

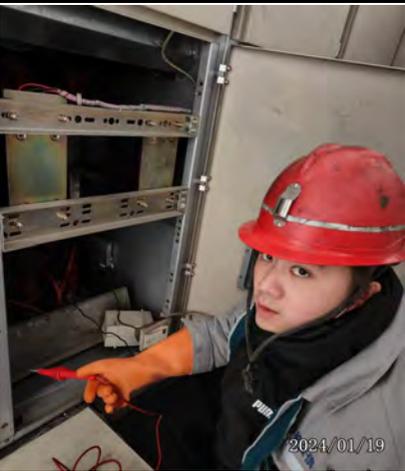
40	GX-B1321/20-2-24070~24072	2024/2/4	所检项目合格

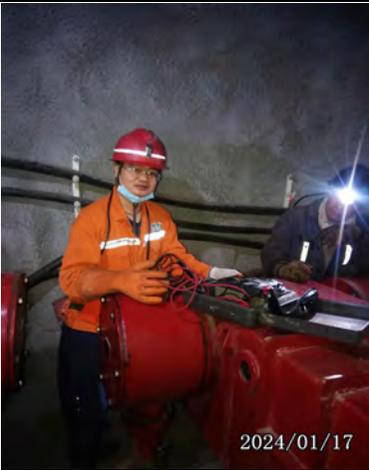
41	GX-B1321/20-2-24054~24058	2024/2/4	所检项目合格

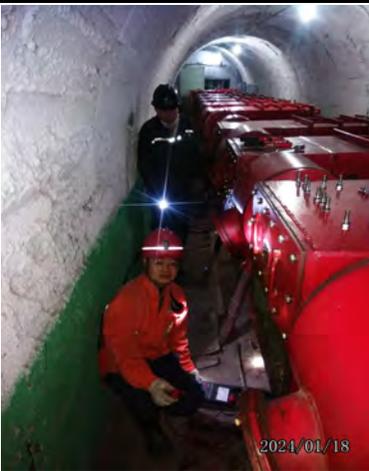
42	GX-B1321/20-2-24059~24064	2024/2/4	所检项目合格

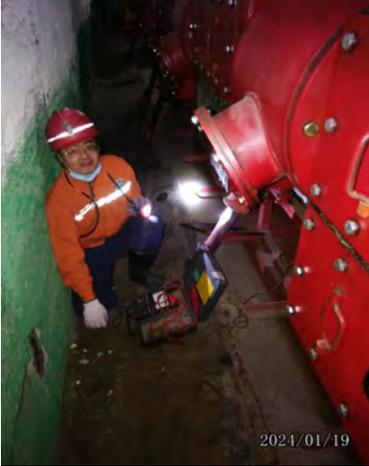
43	GX-B1321/20-2-24073~24077	2024/2/4	所检项目合格

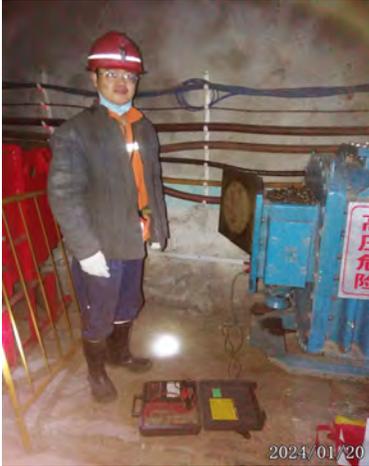
44	GX-B1321/20-2-24078~24081	2024/2/4	所检项目合格

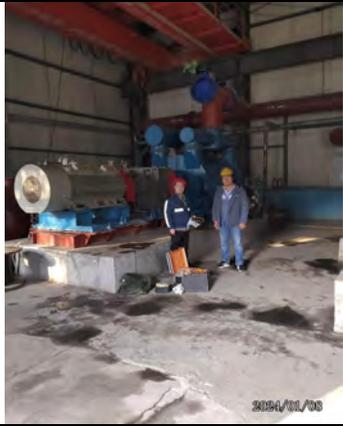
45	GX-B1339/21-2-24001	2024/2/4	所检项目合格。

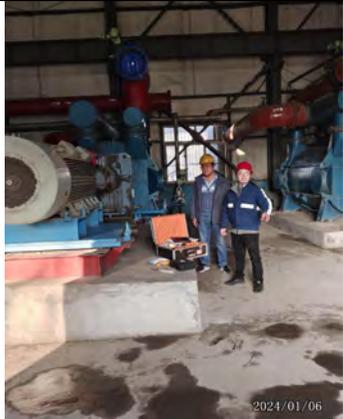
A photograph showing two workers in blue uniforms and hard hats standing in a large industrial facility. They are positioned near a large piece of machinery with blue and red components. The floor is concrete and appears to have some oil stains. A date stamp '2024/01/06' is visible in the bottom right corner of the image.	
46	GX-B1339/21-2-24002	2024/2/4	所检项目合格。

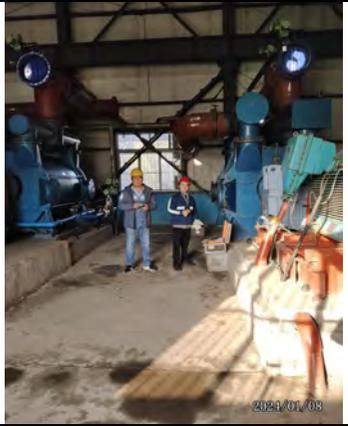
47	GX-B1339/21-2-24003	2024/2/4	所检项目合格。

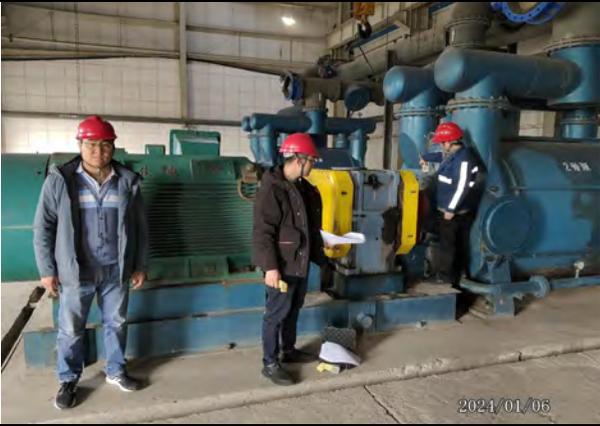
49	GX-B1339/21-2-24005	2024/2/4	所检项目合格。

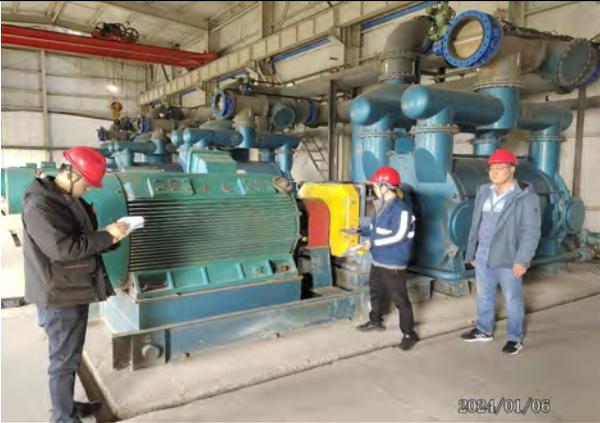
50	GX-B1339/21-2-24006	2024/2/4	所检项目合格。

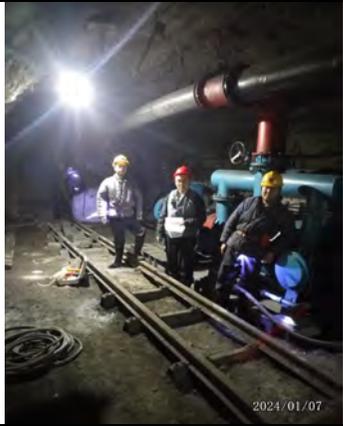
51	GX-B1339/21-2-24007	2024/2/4	所检项目合格。

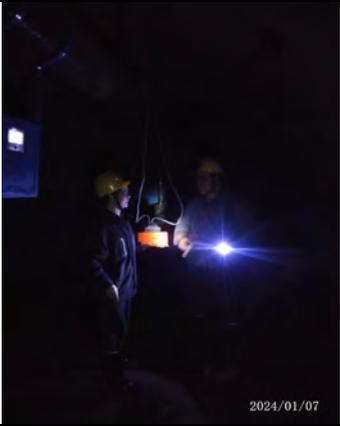
53	GX-B1339/21-2-24009	2024/2/4	所检项目合格。

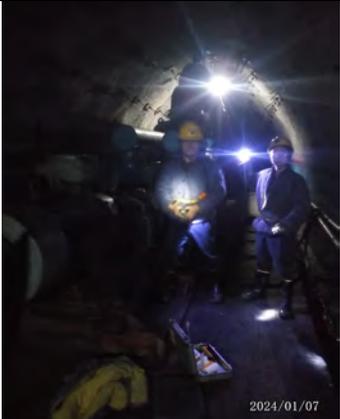
54	GX-B1339/21-2-24010	2024/2/4	所检项目合格。

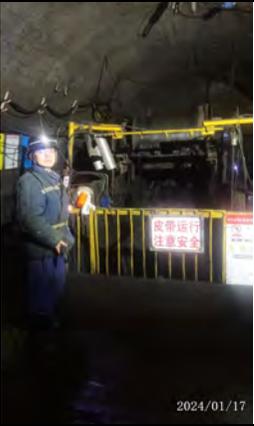
55	GX-B1416/22-2-24005	2024/2/4	综合判定：合格。

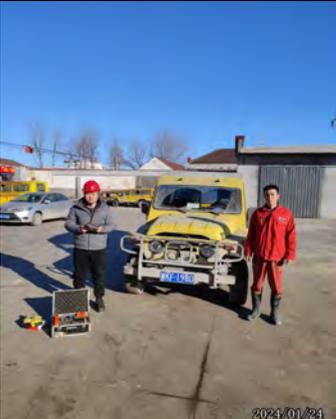
56	GX-B1548/20-2-24001	2024. 2. 5	所检项目合格。

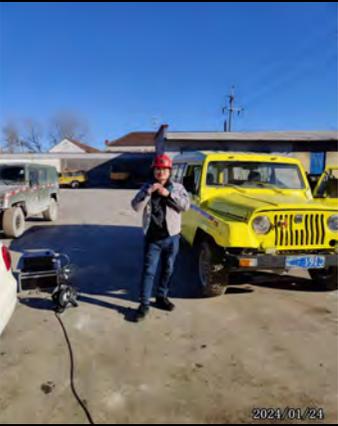
57	GX-B1548/20-2-24002	2024. 2. 5	所检项目合格。

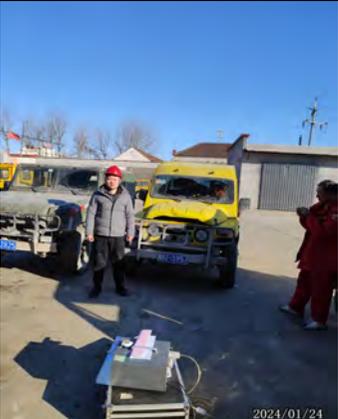
58	GX-B1548/20-2-24006	2024. 2. 5	所检项目合格。

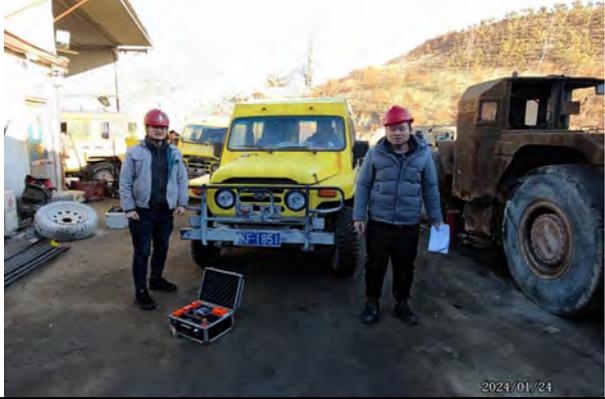
59	GX-B1548/20-2-24003	2024. 2. 5	所检项目合格。

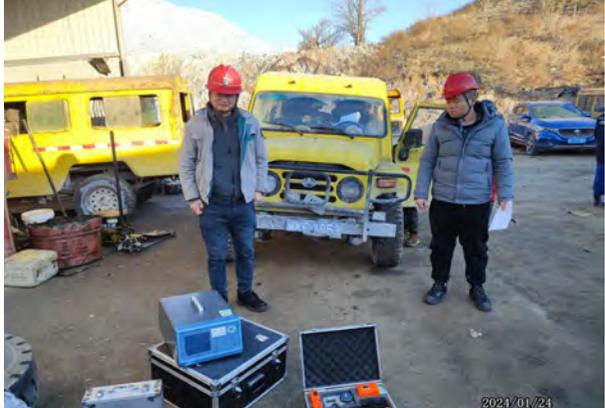
A photograph showing two inspectors in red hard hats and winter jackets standing in front of a yellow truck. One inspector is holding a clipboard. A toolbox is open on the ground in front of them. The truck's license plate is visible and reads '桂B1548'. The background shows an outdoor industrial or construction site with a hillside. <p>2024/01/24</p>
60	GX-B1548/20-2-24004	2024. 2. 5	所检项目合格。

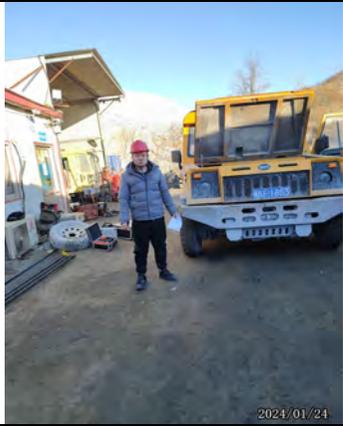
61	GX-B1548/20-2-24005	2024. 2. 5	所检项目合格。

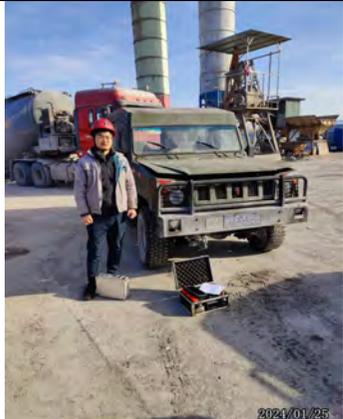
<p>2024/01/24</p>	
62	GX-B1548/20-2-24007	2024. 2. 5	所检项目合格。

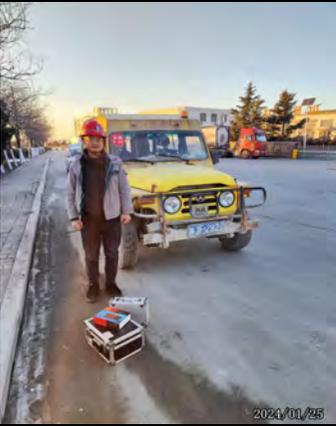
63	GX-B1548/20-2-24008	2024. 2. 5	所检项目合格。

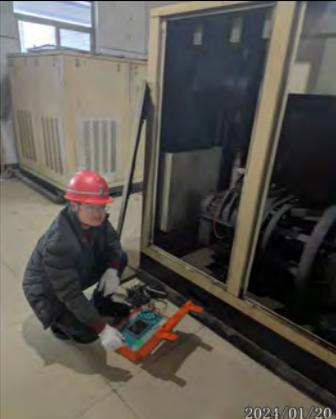
64	GX-B1306/23-2-24004	2024. 2. 5	综合判定：合格。

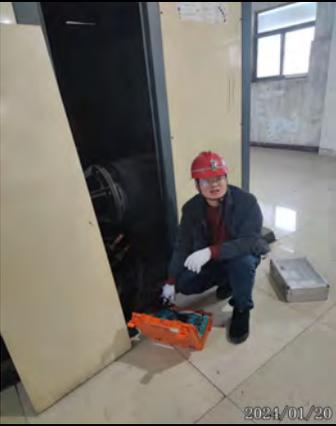
65	GX-B1306/23-2-24005	2024. 2. 5	综合判定：合格。

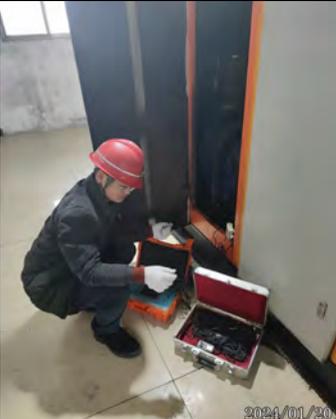
<p>2024/01/20</p>
66	GX-B1306/23-2-24006	2024. 2. 5	综合判定：合格。

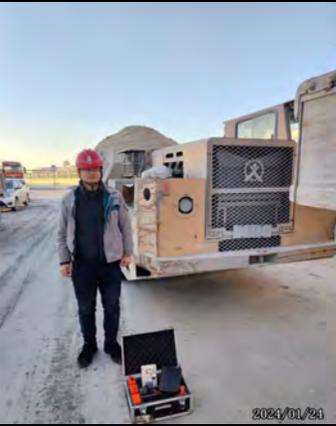
67	GX-B1534/20-2-24001	2024. 2. 5	所检项目合格。

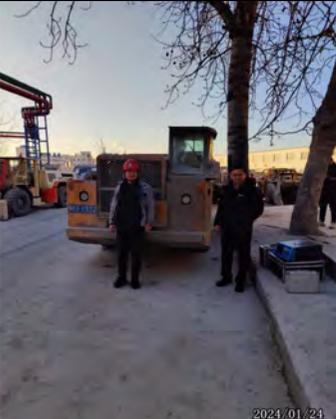
68	GX-B1534/20-2-24002	2024. 2. 5	所检项目合格。

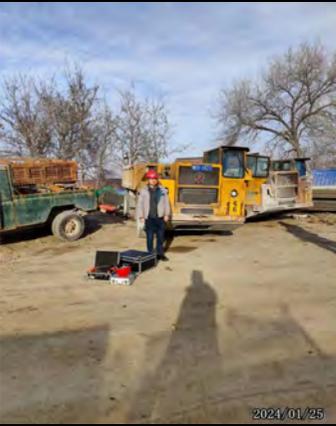
69	GX-B1534/20-2-24003	2024. 2. 5	所检项目合格。

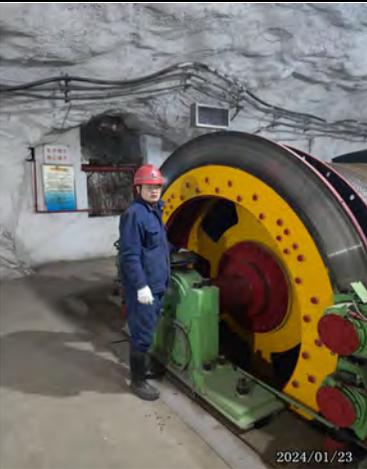
91	GX-B1310/21-2-234011	2024/2/5	符合标准要求

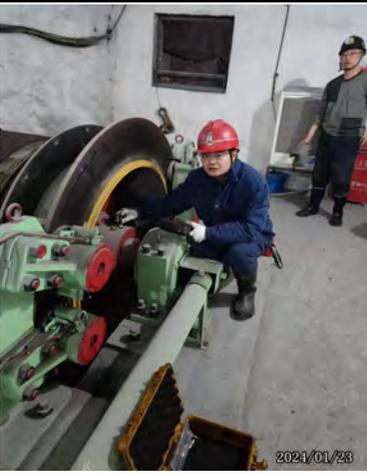
92	GX-B1310/21-2-234012	2024/2/5	符合标准要求

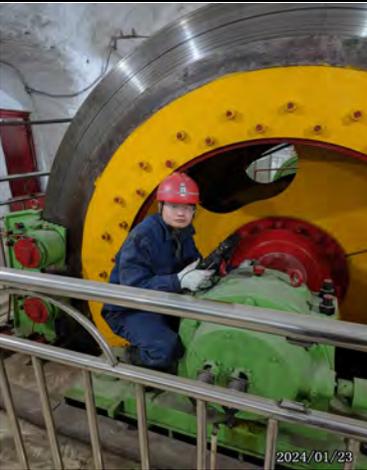
93	GX-B1310/21-2-234013	2024/2/5	符合标准要求

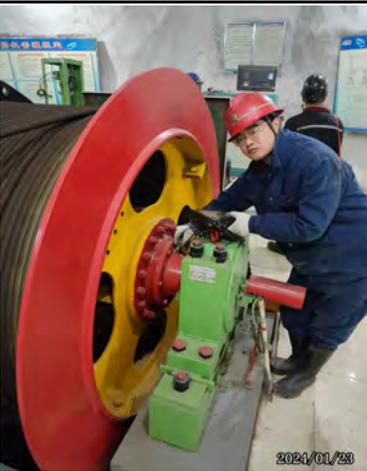
94	GX-B1310/21-2-234014	2024/2/5	符合标准要求

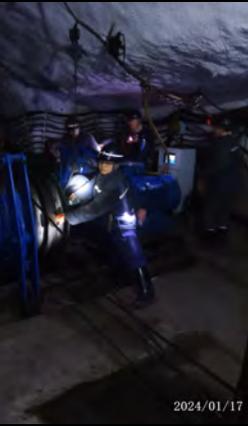
95	GX-B1515/22-2-24001	2024. 2. 5	滚筒绳衬直径与钢丝绳直径之比小于50倍。除上述问题外，其余所检项目合格。

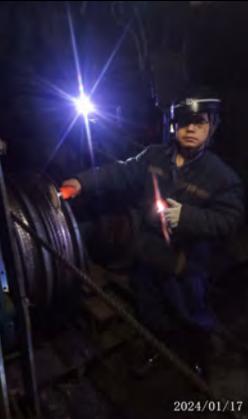
96	GX-B1515/22-2-24002	2024. 2. 5	滚筒绳衬直径与钢丝绳直径之比小于50倍。除上述问题外，其余所检项目合格。

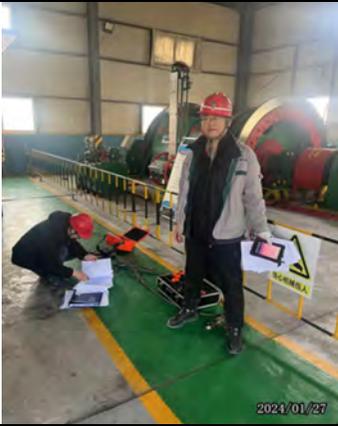
97	GX-B1303/21-2-24001	2024. 2. 4	综合判定：合格。

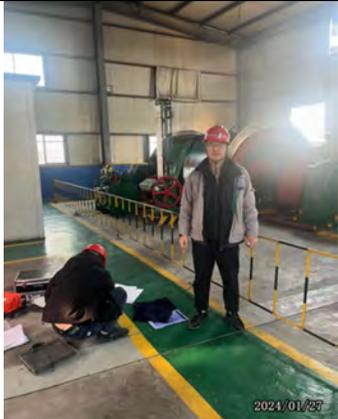
98	GX-B1303/21-2-24002	2024. 2. 4	综合判定：合格。
